TOPIC: Spin-on Oil Filters

SAFETY ALERT

IDENT NO: 12-4005A

SUBJECT: Inspection of Spin-on Oil Filters

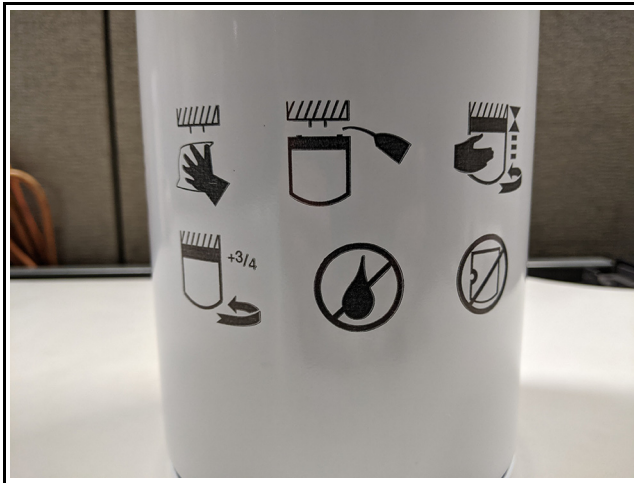
Figure 1

- At the first opportunity, check all spin-on oil filters for damage to the filter canister (see Figure 1).
